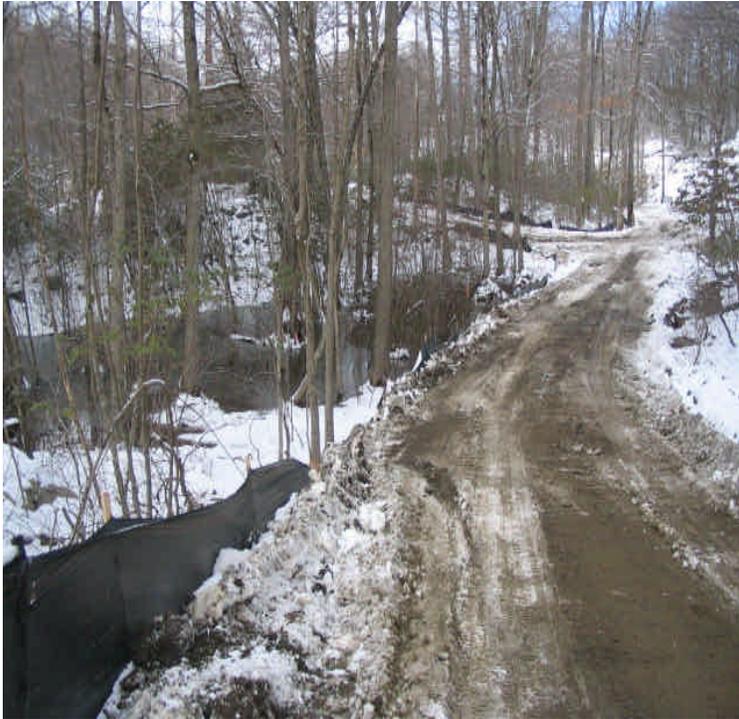
(Composite Section): Photo on the left shows an overview of the access road leading from Archers Lane to the ROW with snow plowed over the silt fence. Photo on the right shows where sediment has passed through the silt fence and settled in the adjacent wetland. 1/4/06

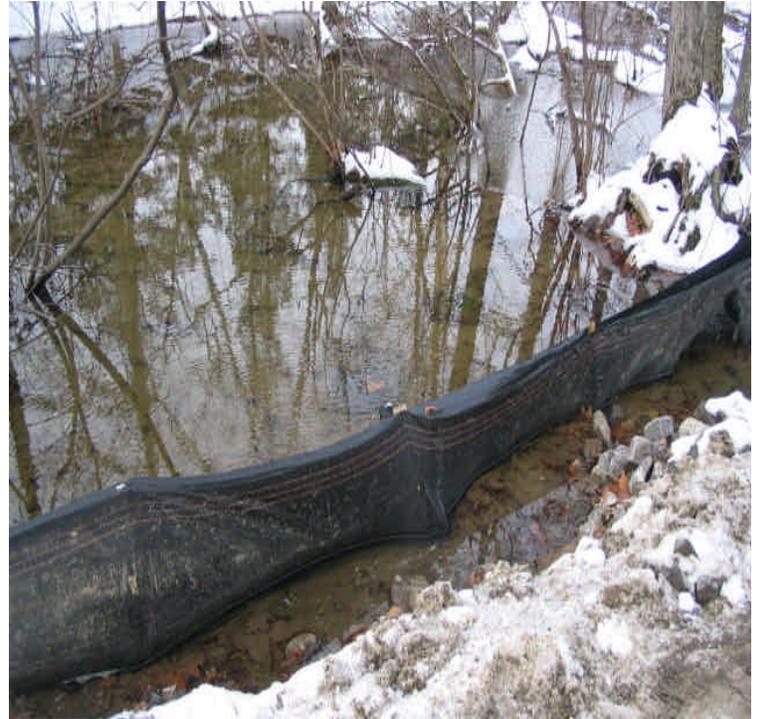
<p>Erosion and Sediment Controls (includes inspection within 24 hours of a storm event) Erosion and Sediment Controls</p> <p>Composite</p>	<p>-Water has been flowing through/under the silt fence at the wetland crossing past Archers Lane and turbidity has been noted here. 12/01-1/4/06. With snow plowing, additional potential sediment issues were noted. 1/4/06</p> <p>- The access roads were plowed, creating snow pile issues over the silt fence in numerous locations. 1/4/06</p>	<p>- The silt fence should be extended, towed in, and/or repaired as necessary (or the haybale line should be continued along the low point to prevent turbidity). 12/8-1/4/06. Solutions need to be investigated.</p> <p>-Silt fence adjacent to wetlands need attention and snow cannot continue to be piled over the controls. 1/4/06</p>

<p>Inland Wetland and Watercourse encroachment and mitigation</p> <p>Composite</p>	<ul style="list-style-type: none"> -The D&M plan approved stone on geotextile fabric at the wetland crossings had worked well, but at the two areas near Archers Lane, turbid water continues to enter the ponded water here. 12/8-1/4/06 - The rocks at the crossings 	<ul style="list-style-type: none"> - As the access is considered temporary, the stone will be removed when final work ends so the wetlands can be restored. Extend and/or toe in areas of silt fence, add haybales, or develop other solutions to prevent additional turbidity. 12/8-1/4/06

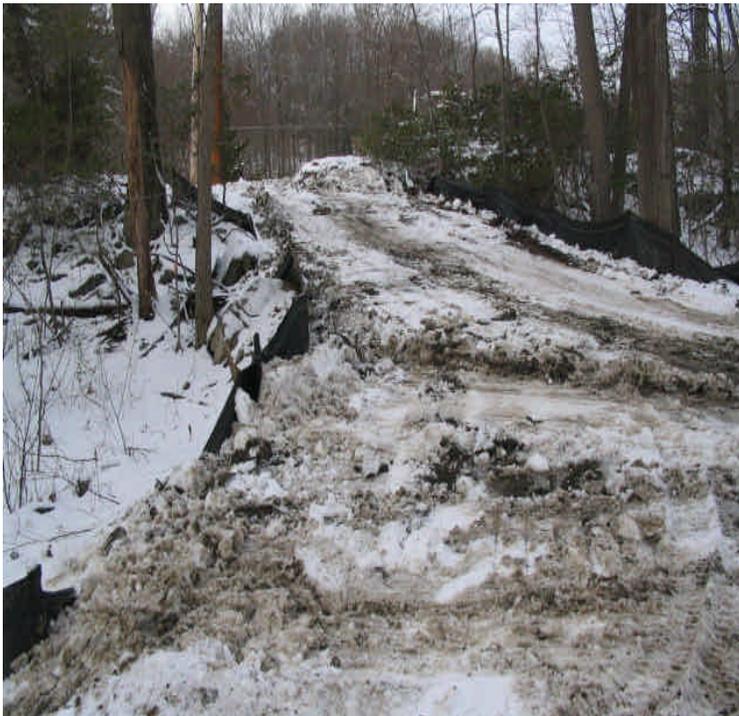
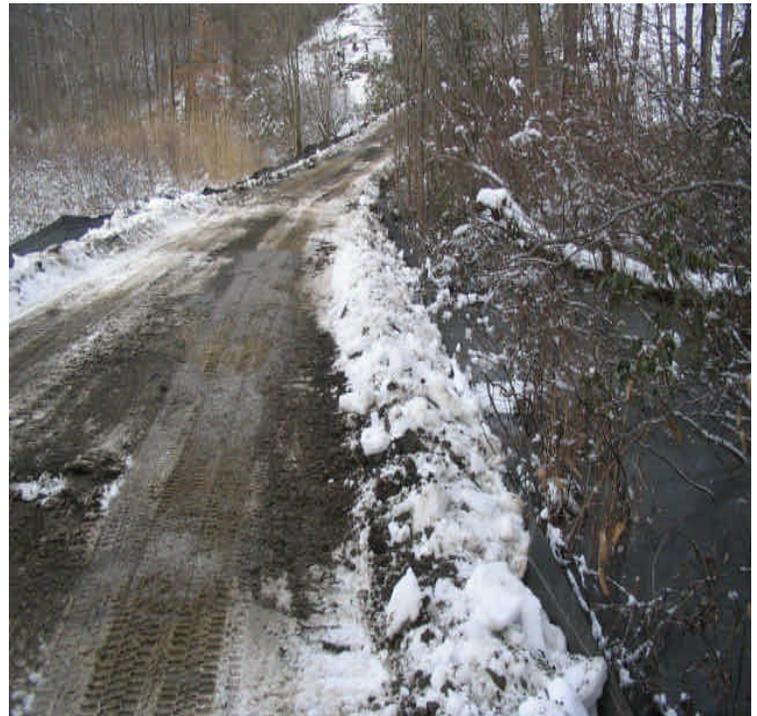
Both photos show views of the access roads where snow and sediment was piled up over the silt fence in a number of locations during plowing. Either temporary roads have to be built wider to accommodate this or snow has to be pushed to designated locations. 1/4/06

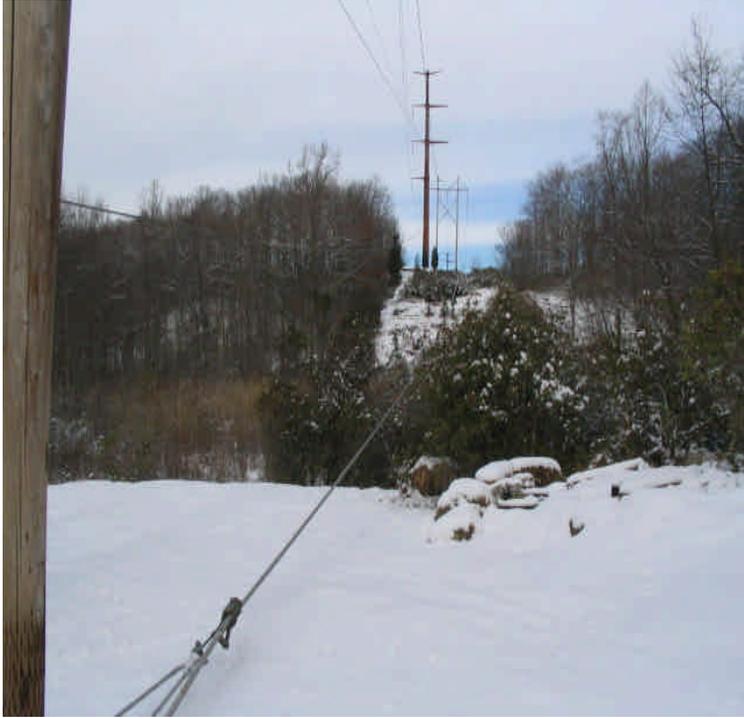
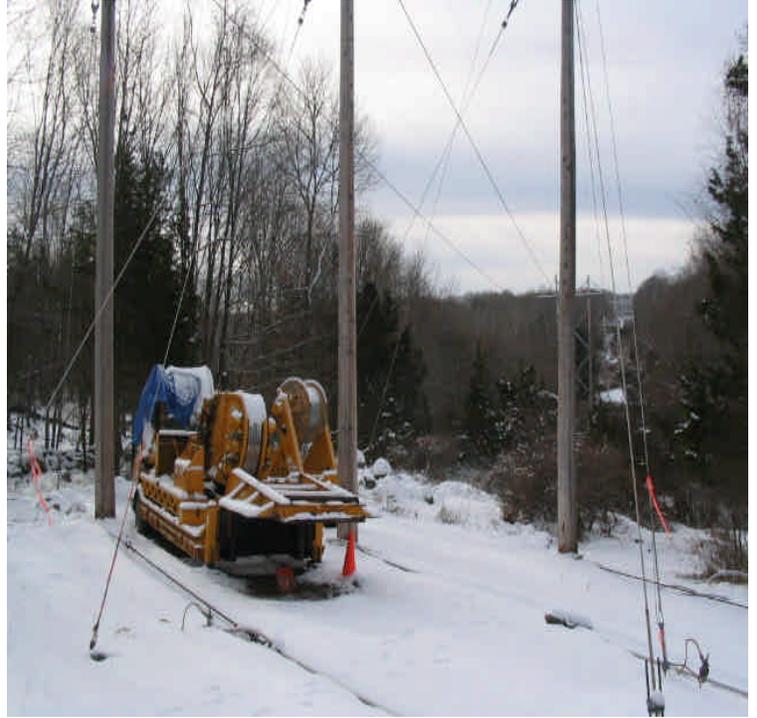
Both photos show views of preparation for pole removal at some of the old wooden structures.
1/4/06

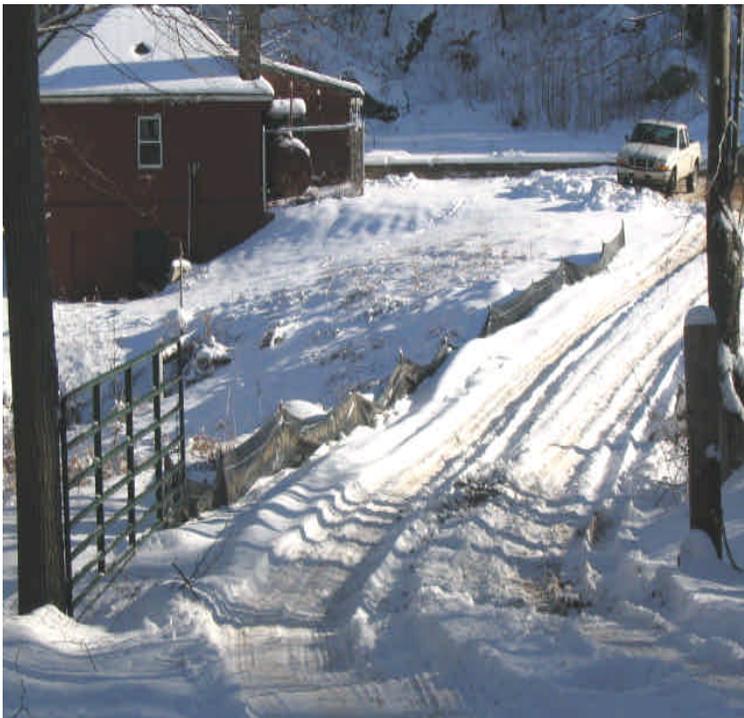
345kV (H-Frame Section): Photo on the left shows where stone was recently installed to stabilize the access road in from the Bethel Reservoir land. Photo on the right shows some of the trees adjacent to the stream will need to be removed for ROW expansion. They will be felled towards the mats. 1/4/06

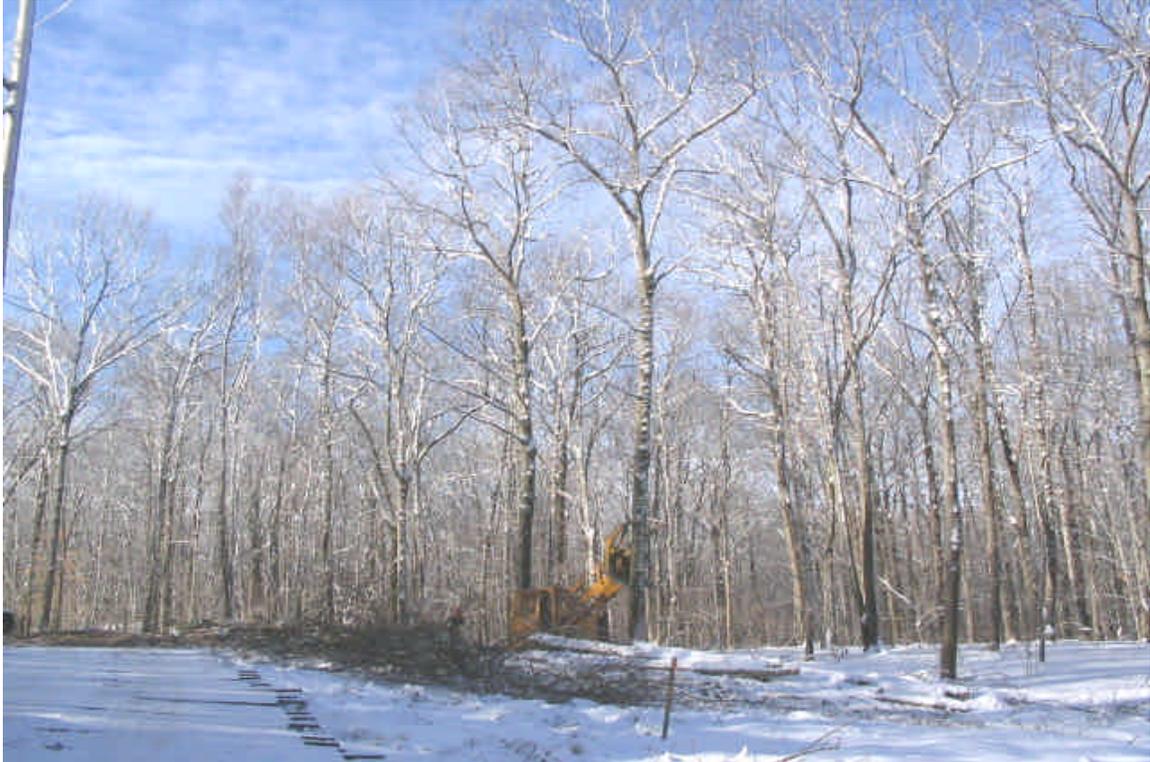
View of tree clearing operations along the ROW. 1/4/06

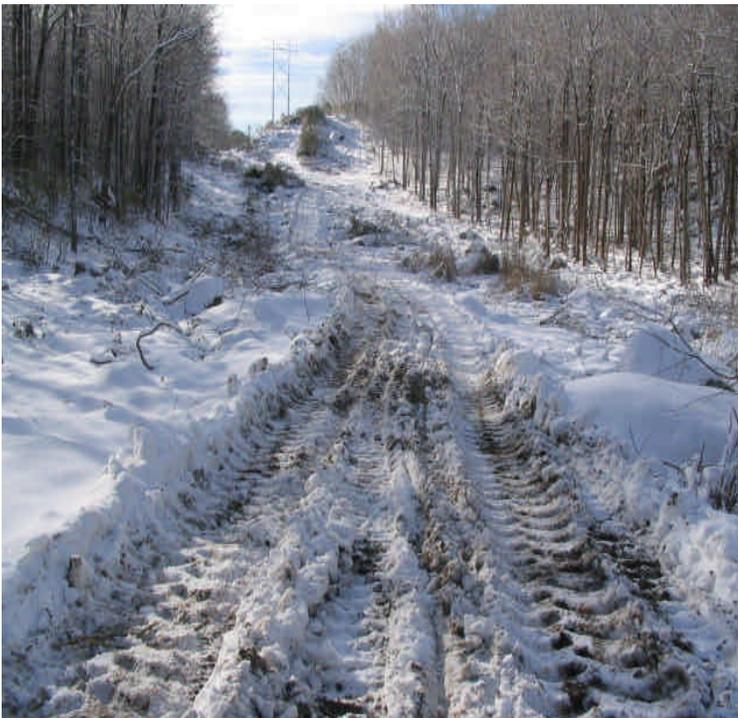
Photo on the left shows an overview of the ROW and access road. Ruts are deepening, even with snow cover so mats will be installed along the wetland. Photo on the right shows a close up of the wetland ruts created a few weeks ago. If any channelization is noted during the thaw, wetland repairs may be needed. 1/4/06

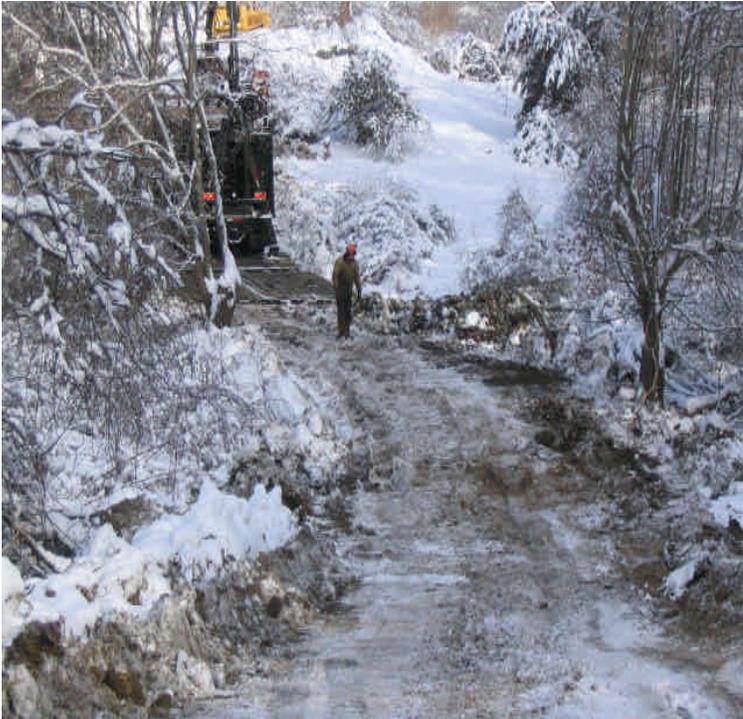
Photo on the left is a view of access road creation for continuing clearing on the ROW portion between Chestnut Ridge Rd. and Hoyts Hill. Photo on the right shows where snow plowing has created sediment/snow piles that require controls. Additional mats are being installed and more silt fence was recommended. 1/4/06

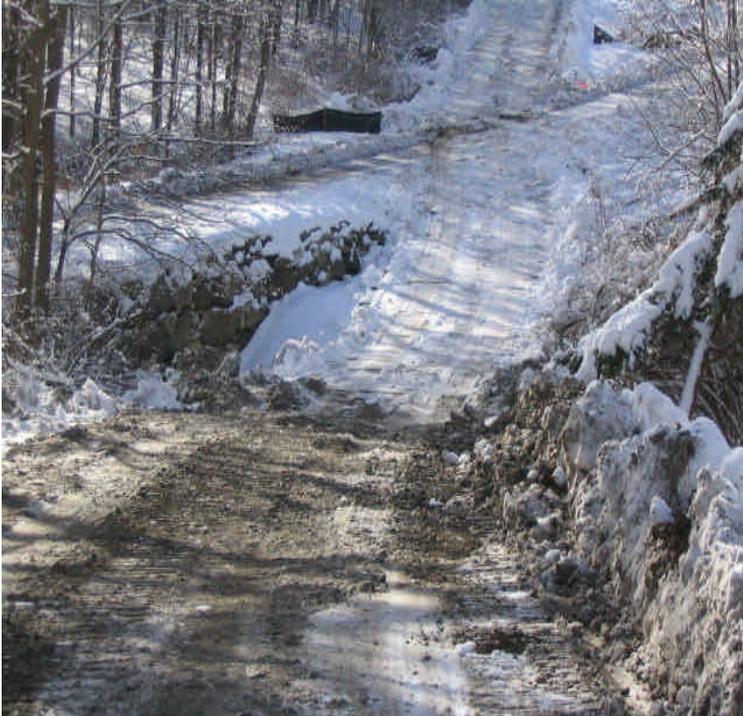
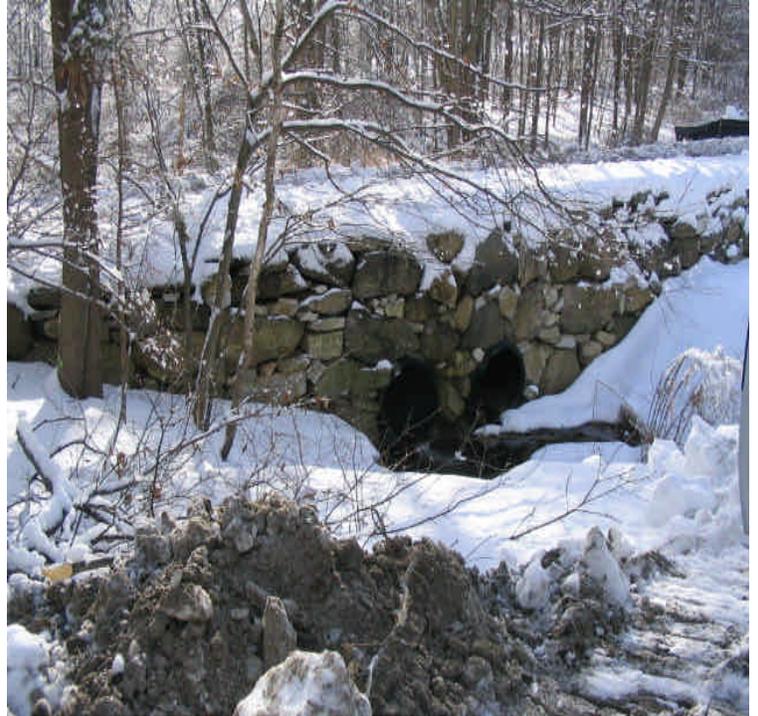
View of a constructed stream crossing using a number of mats. Again, silt fence was recommended along the edge of the stream to prevent sediment/snow piles and tracked sediment from migrating into the water. 1/4/06
